Manhole Inspection Summary

Manhole # S45UU_024MH

Insp Date: **2/6/07 11:40 AM**

Location Address: **1828 28TH AVE**

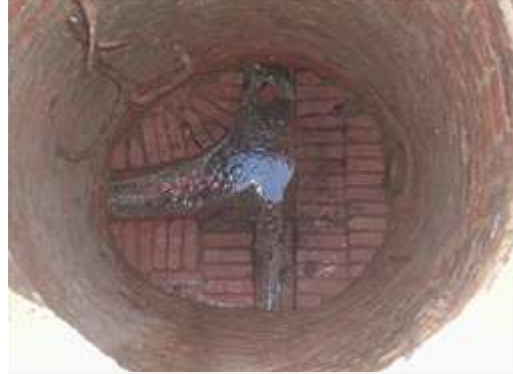
Top View

Corroded and missing steps. Bench and Channel debris.

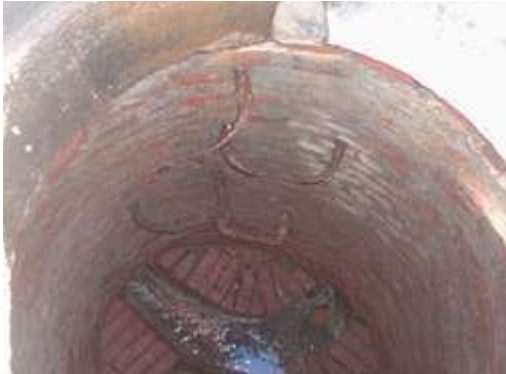
Defect

Frame leaks. Adjustment deterioration and infiltration. Barrel infiltration.

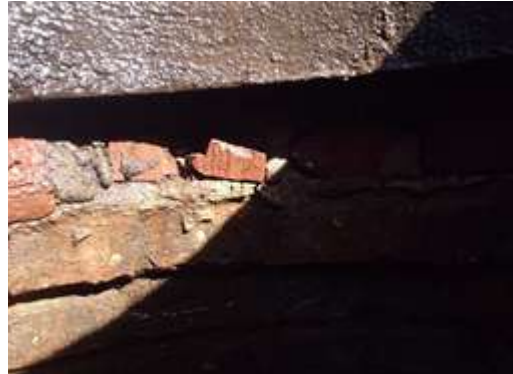
Defect

Frame leaks. Adjustment deterioration and infiltration.

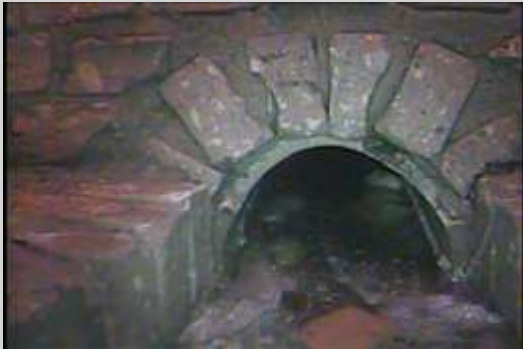
8 in. Circular Gravity Sewer Pipe Out @ 12 O'Clock

Deposits: ☐ None ☒ **Mud** ☐ Sludge ☒ **Debris** ☒ **Grease**

Silt Depth: **2** (in.) Deposits Extent: **Light**

Infiltration: **Evidence** Pipe Seal Cond: **Unknown**

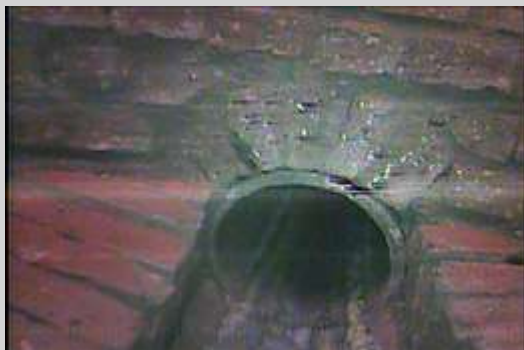
Pipe In @ 9 O'Clock

Deposits: ☐ None ☐ Mud ☐ Sludge ☐ Debris ☒ Grease

Silt Depth: **0** (in.) Deposits Extent: **Light**

Infiltration: **Evidence**
